SECTION 32 PROGRAM
STREAMBANK EROSION CONTROL
EVALUATION AND DEMONSTRATION
WORK UNIT 2-EVALUATION OF EXISTING
BANK PROTECTION

FIELD INSPECTION OF SITES IN THE
MISSOURI RIVER DIVISION

October 1980

Inspection Report 10

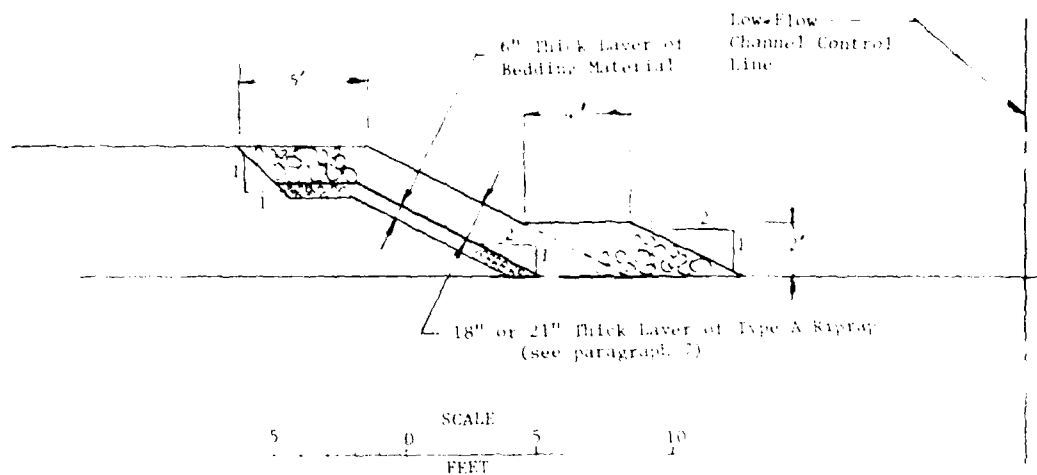
7. The side slopes of the low-flow channel were protected by an 18-in.-thick layer of Type A stone riprap placed over a 6-in.-thick layer of bedding material in reaches where minimum protection was required (Figure 4); in high-velocity or turbulent environments (bends, downstream from structures, etc.), a 21-in.-thick layer of Type B riprap was placed over the bedding material. Riprap was required at 12 locations through the Stage I reach (Figures 3 and 5) to stabilize the low-flow channel. All materials were brought onsite by truck; an orange peel bucket and crane was then used for below water placement, and a Gradall for above water placement. The Type A and Type B stone riprap was specified to meet the following gradations:

Figure 4. Little Blue River at Independence, Mo. Slope of low-flow channel protected by stone riprap (13 September 1945)

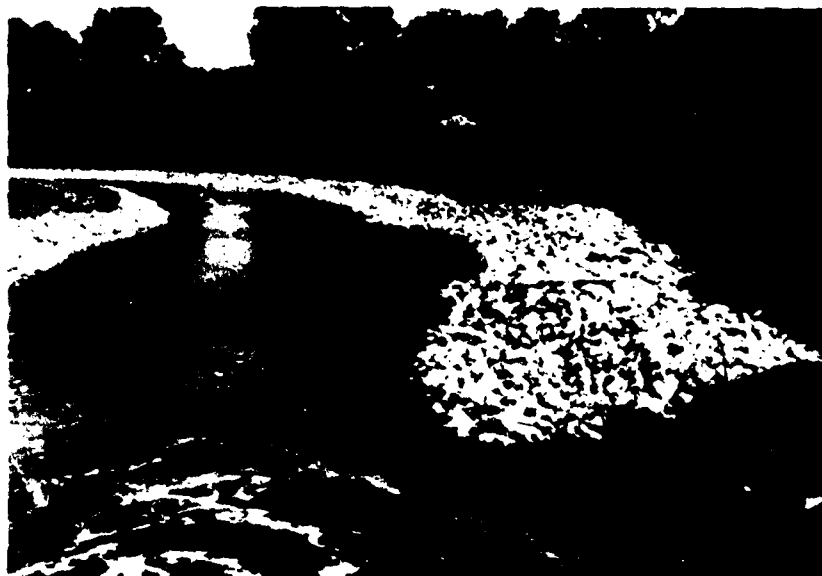
Figure 5. Little Blue River at Independence, Mo. Slope of low-flow channel protected by stone riprap (13 September 1945)

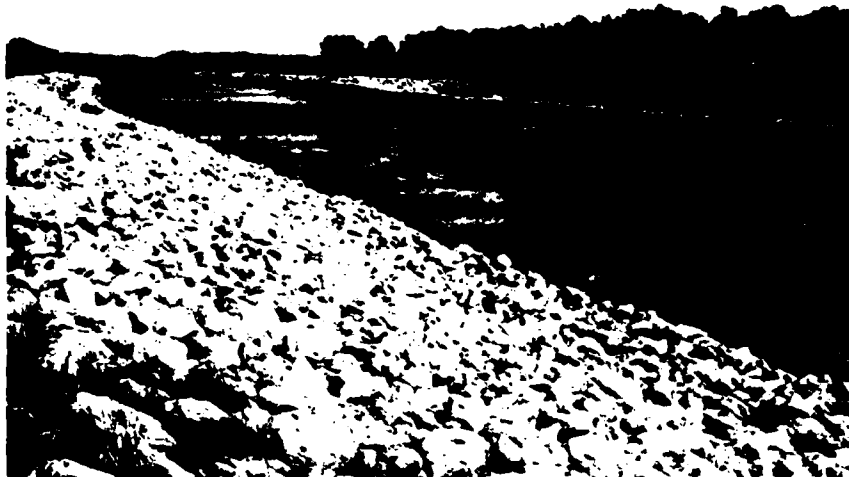
Figure 24. Republican River at Milford Dam Outlet Channel, Kans. General appearance of the middle reach of the outlet channel at the time of the May 1977 inspection. (Source: Reference 11)

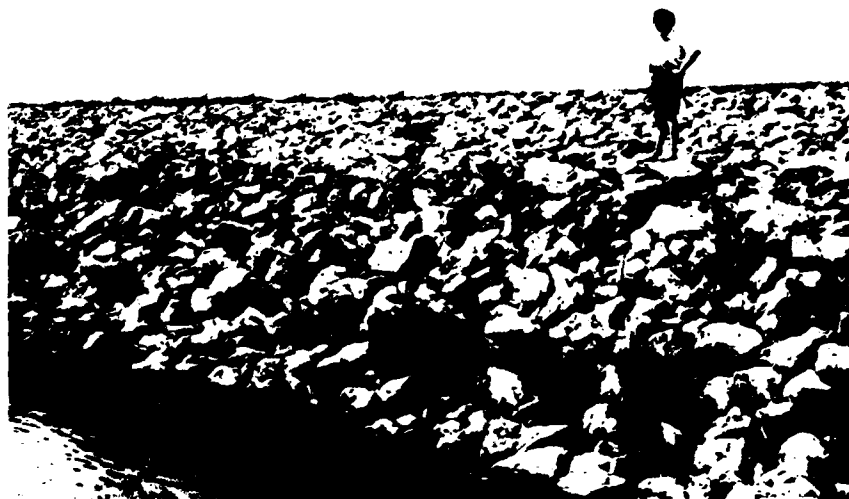
Figure 25. Republic River at Milford Dam Outlet Channel, Kans. Typical view of the revetment toes as seen by the MRD-MRK inspection team in May 1977. The engineer in the photograph is standing on the horizontal blanket at the break in slope between the blanket and the slope to the water. (Source: Reference 11)

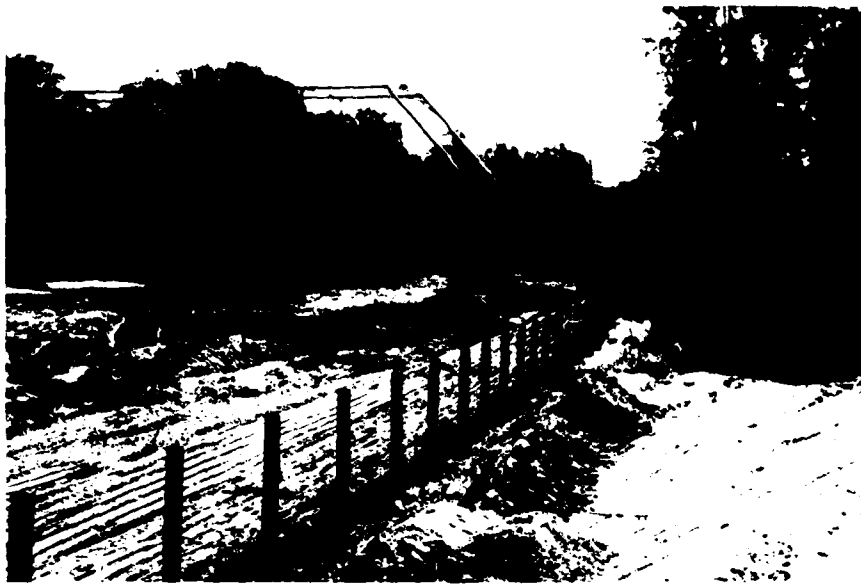
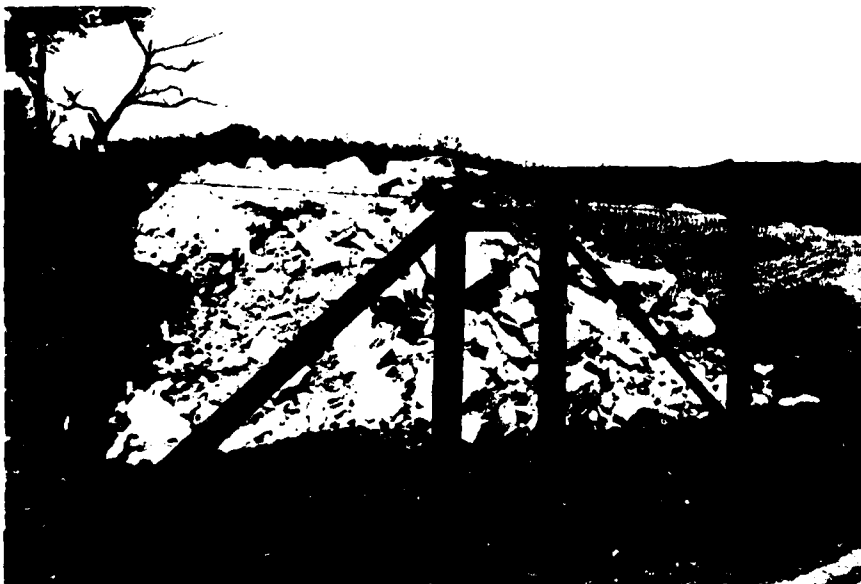
a. Downstream view of wire fence revetment. Schroyer Bridge is in the background

b. Wire fence revetment viewed toward end of dike 3

Figure 38. Big Blue River near Marysville, Kans. Two views of the completed project. (July 1977)

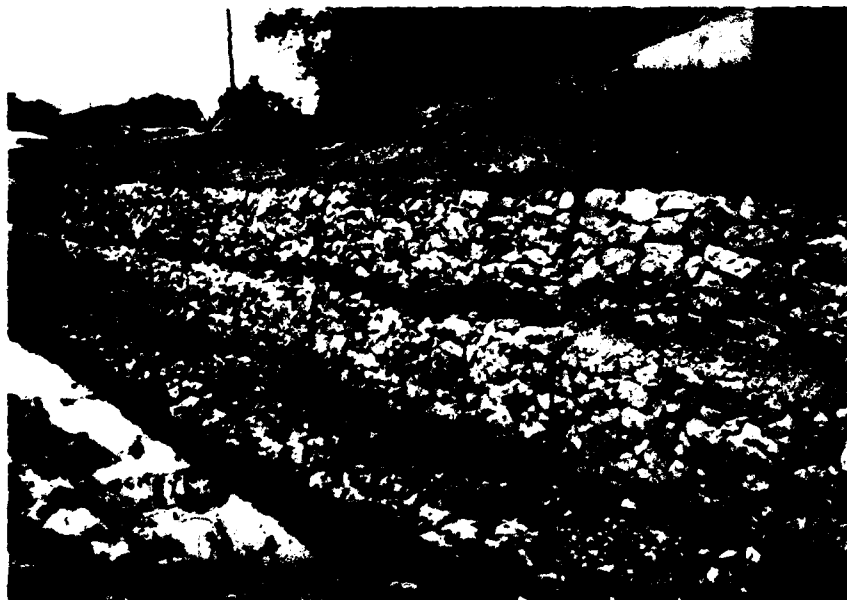
Figure 2. Large rectangular stone structure at Lincoln, Iowa. This view was taken from the west end of the wall and looking eastward. The stone is the front face of the wall and was covered in a thin layer of white plaster. This view was taken from the Hillcrest Street bridge. (September 1977)

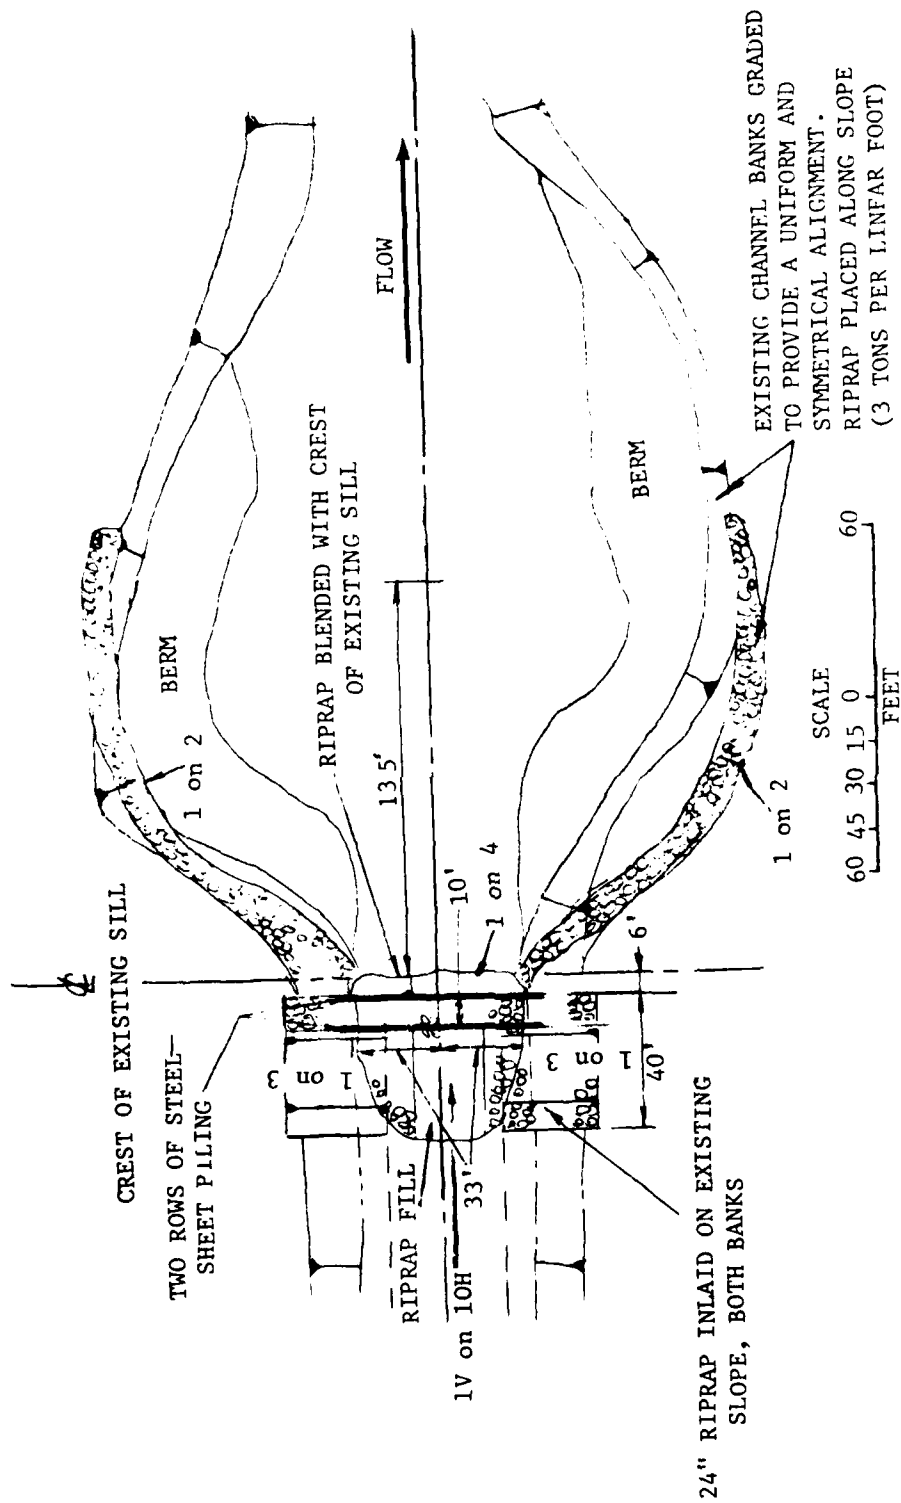
Figure 56. West Fork Ditch at Onawa, Iowa. Plan view of 1973 sill modification

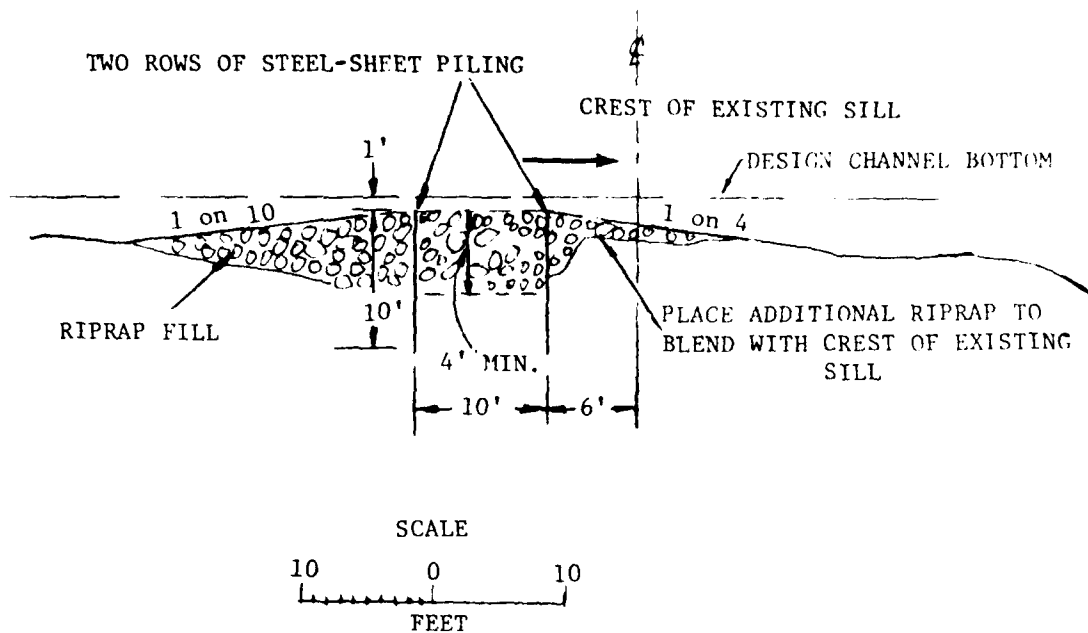
Figure 57. West Fork Ditch at Onawa, Iowa. Cross-sectional view (structure center line) of 1973 sill modification

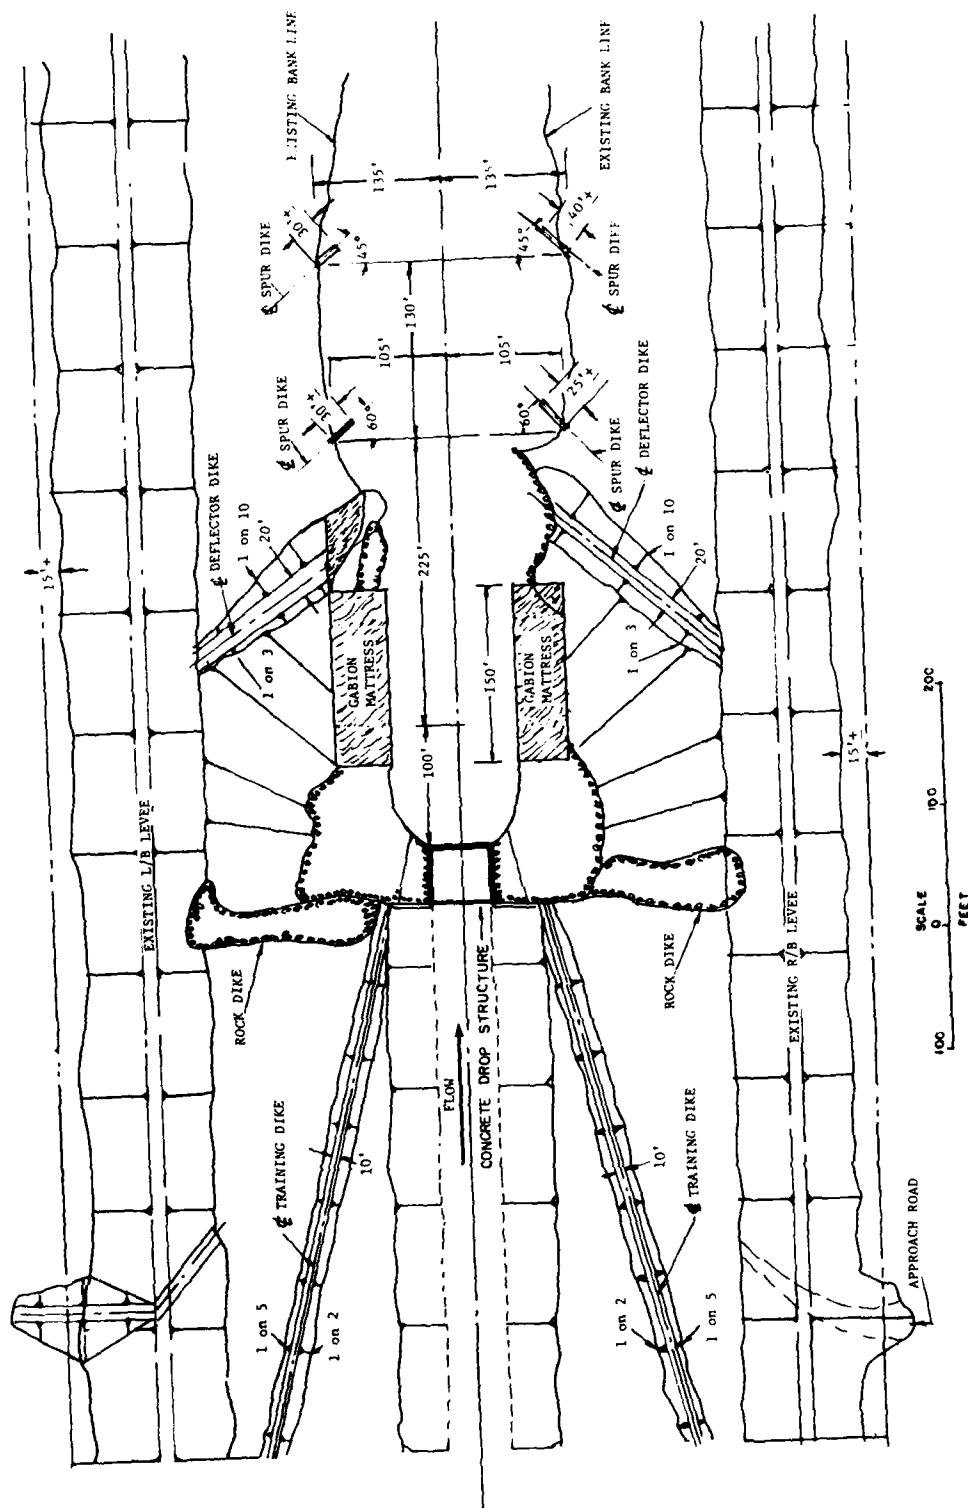
Figure 60. Little Sioux River at Onawa, Iowa. Plan view of grade-control structure #4 and gabion mattresses (adapted from WRD file information)

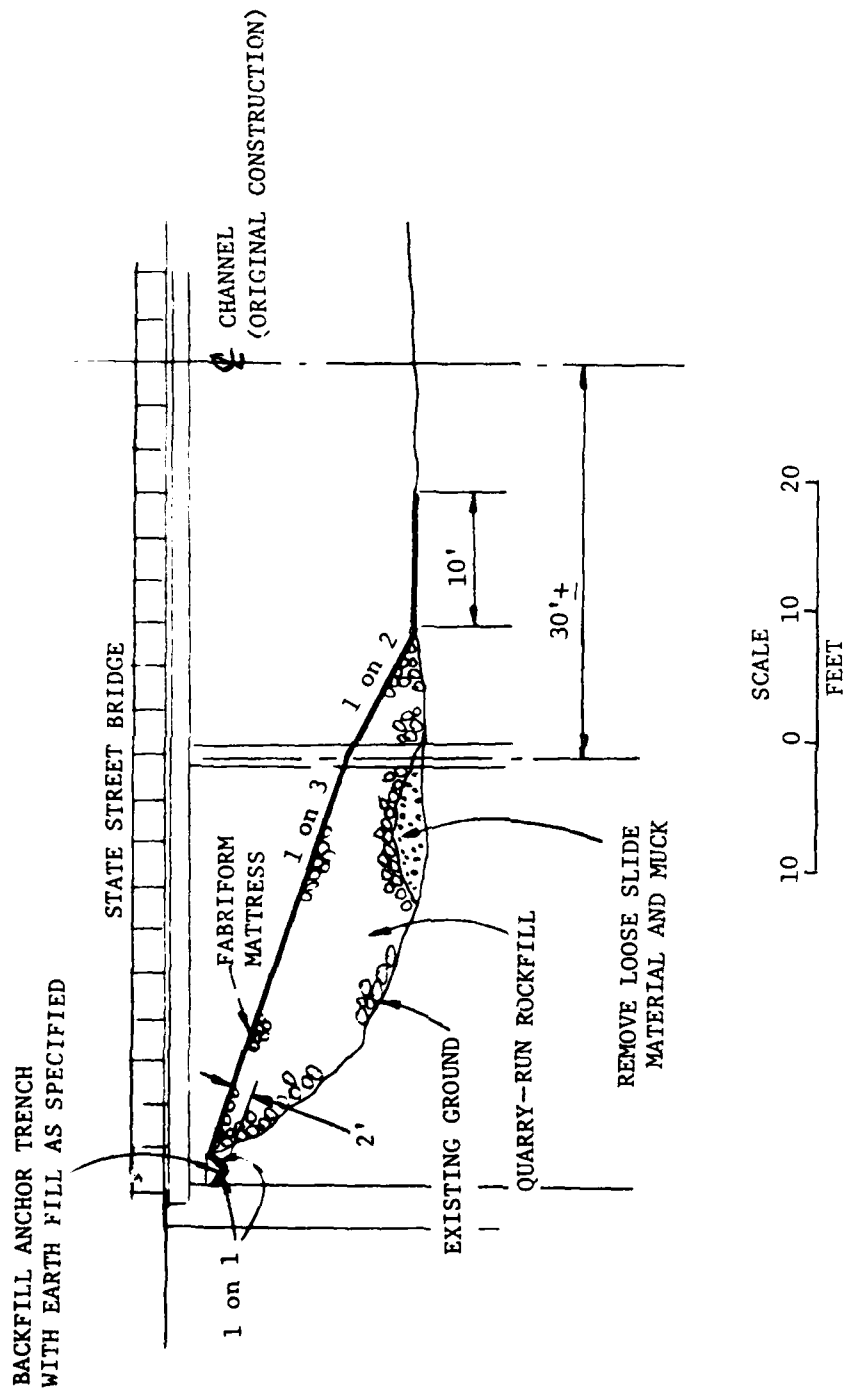
Figure 68. 102 River (East Fork) at Bedford, Iowa. Fabriform revetment on left bank at State Street Bridge (sta 52+42)

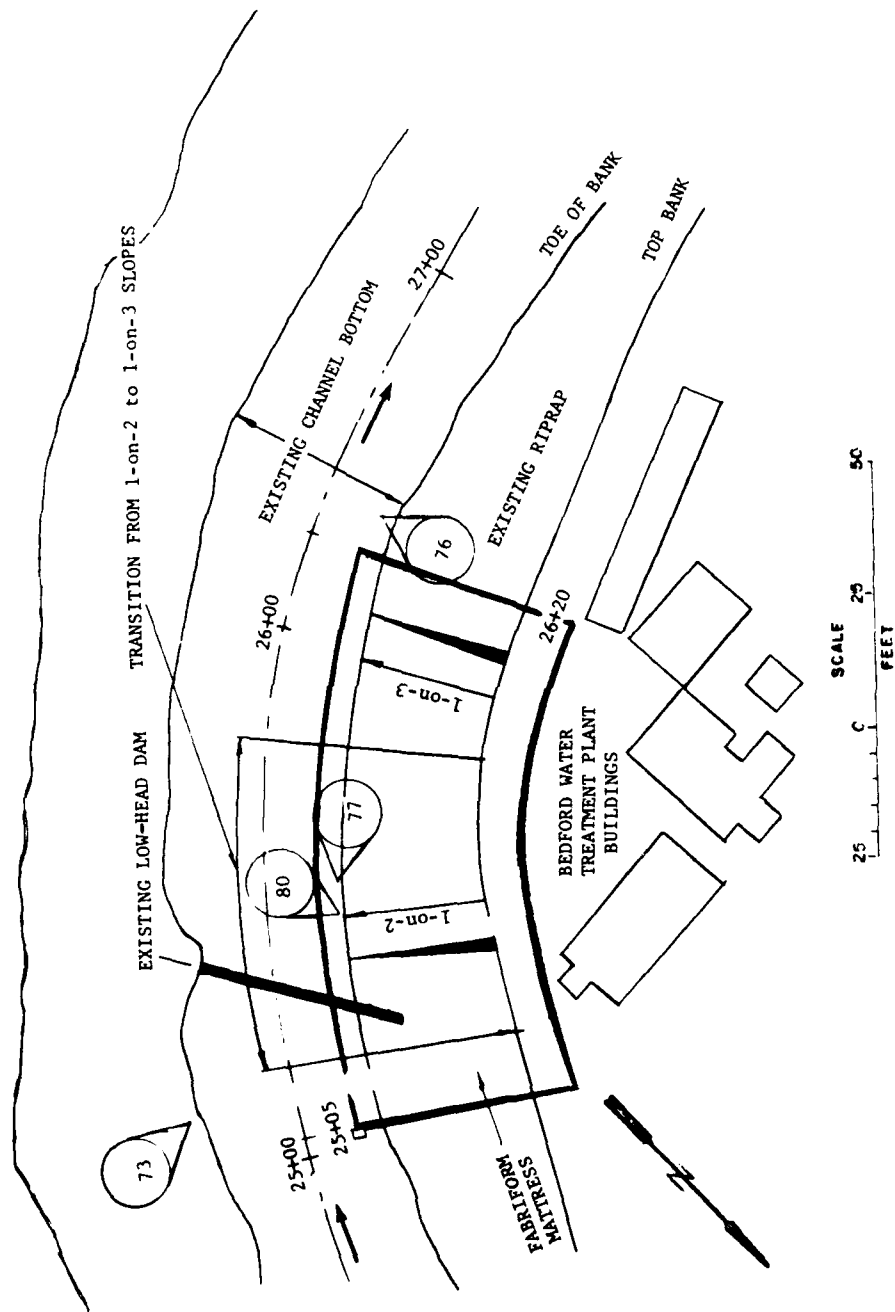
Figure 69. 102 River (East Fork) at Bedford, Iowa. Plan view of Fabriform revetment at Bedford Water Treatment Plant (sta 25+75). Orientation of field-of-view and location from which photograph was taken are represented by

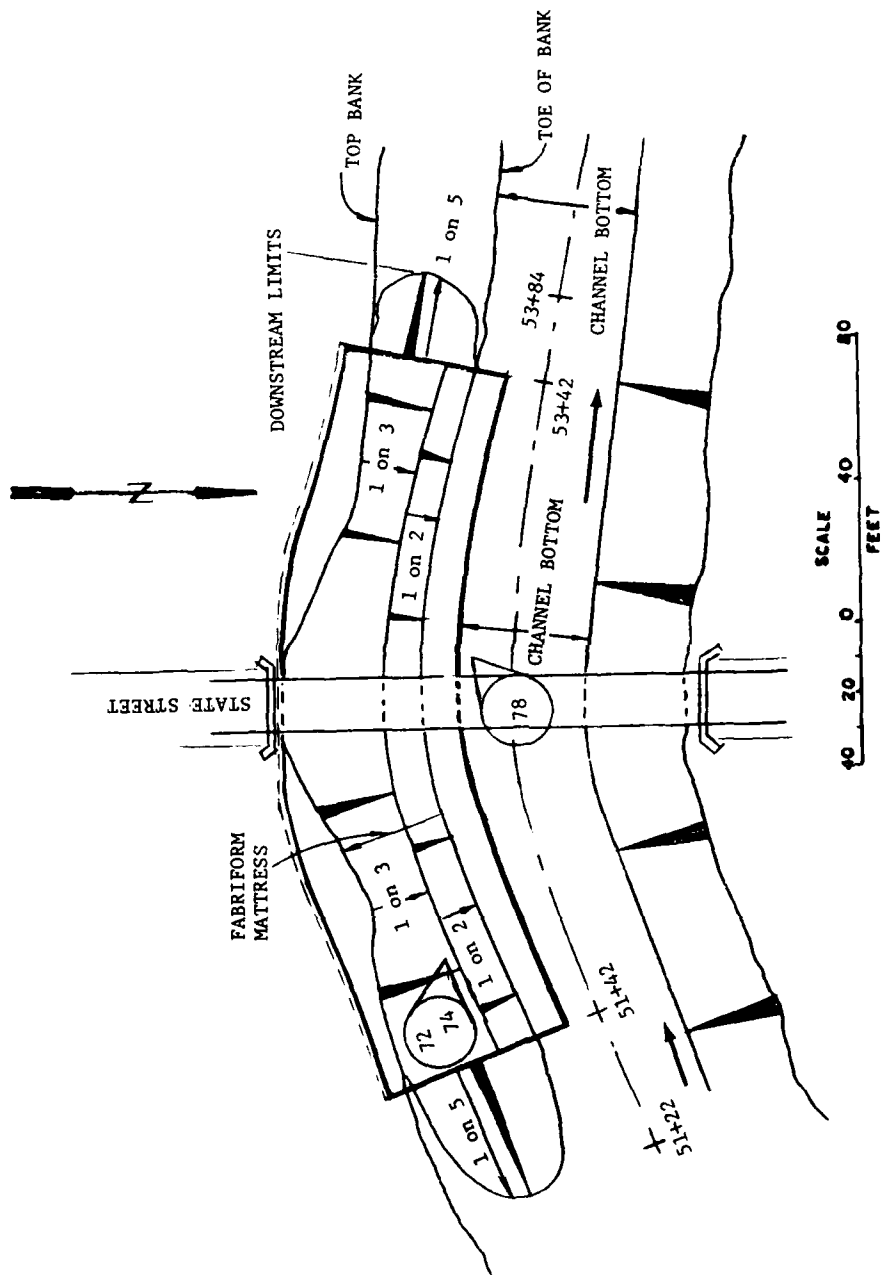
Figure 70. 102 River (East Fork) at Bedford, Iowa. Plan view of Fabriform re-
vetment of left bank at State Street Bridge (sta 52+42). Orientation of field-
of-view and location from which photograph was taken are represented by

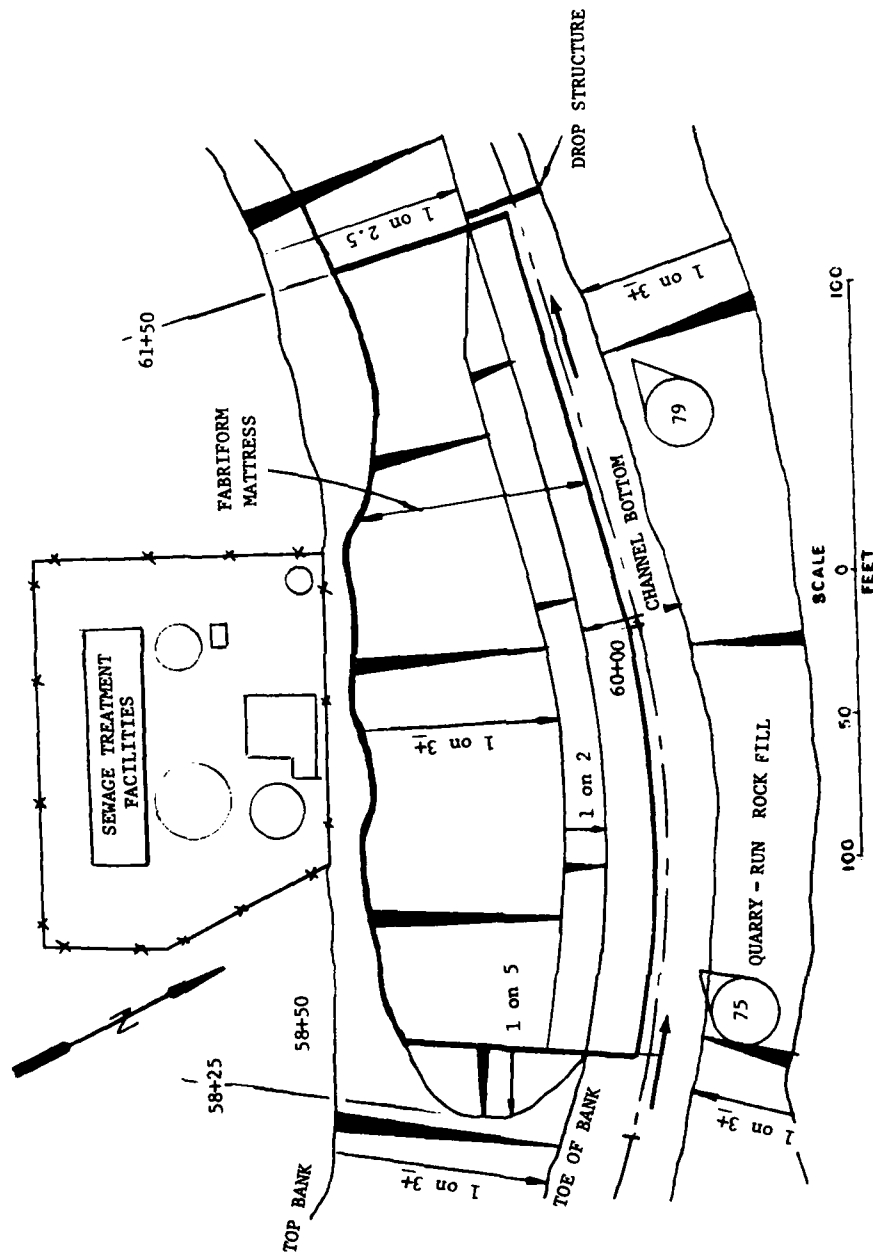
Figure 71. 102 River (East Fork) at Bedford, Iowa. Plan view of Fabriform revetment at Bedford Sewage Treatment Plant (sta 60+00). Orientation of field-of-view and location from which photograph was taken are represented by

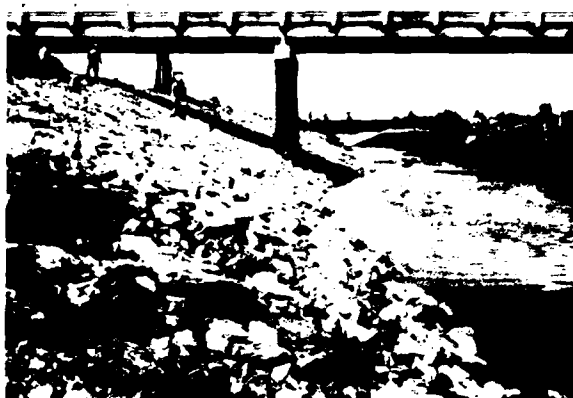
Figure 72. 102 River (East Fork) at Bedford, Iowa. Quarry-run riprap was used to shape the bank prior to placement of Fabriform. View is of the left bank of the State Street Bridge (photograph courtesy of Construction Techniques, Inc.)
